TECHNICAL REPORT RD-TE-87-7

SHIRLDING EFFECTIVENESS MEASUREMENT OF THE SCI SHIRLDED ENCLOSURE

Robert A. Snead Test and Evaluation Directorate Research, Development, and Engineering Center

December 1987

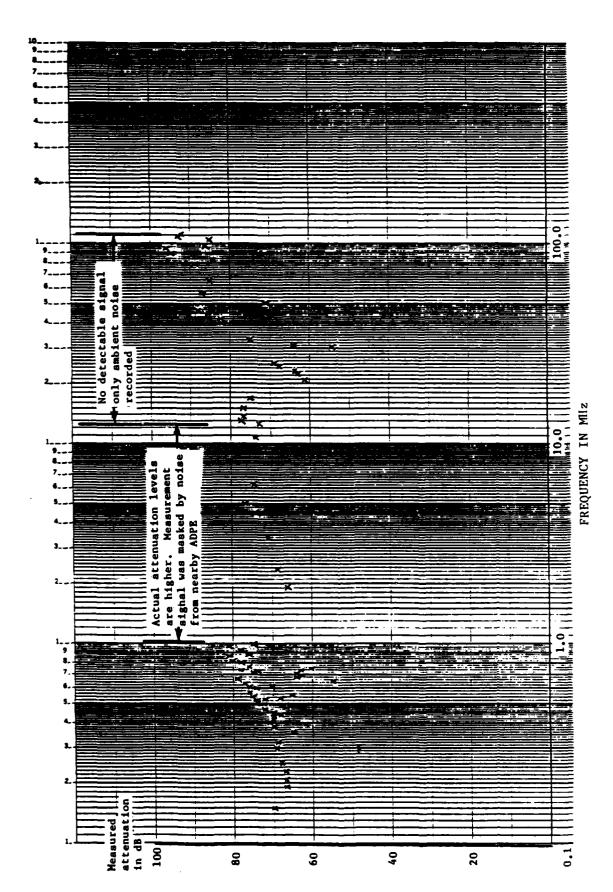
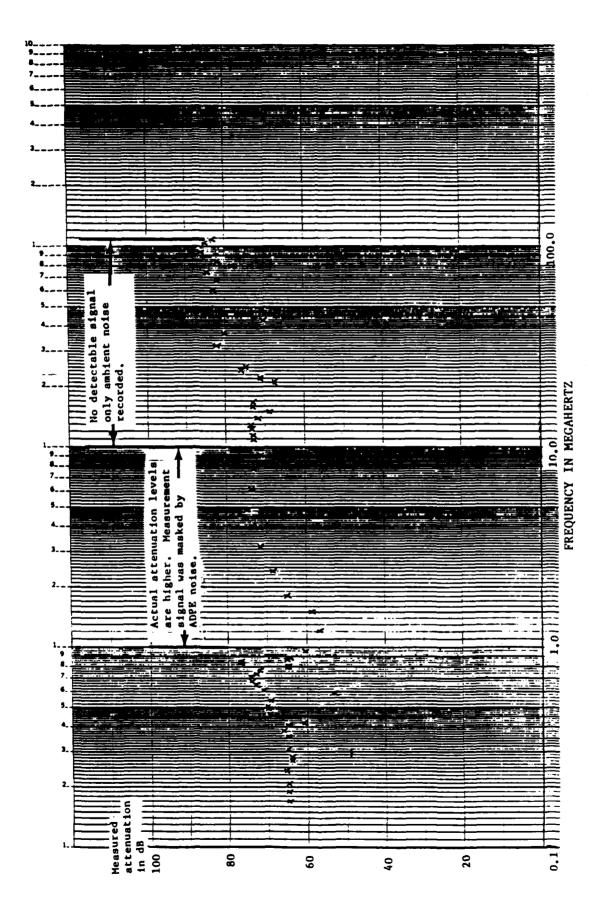
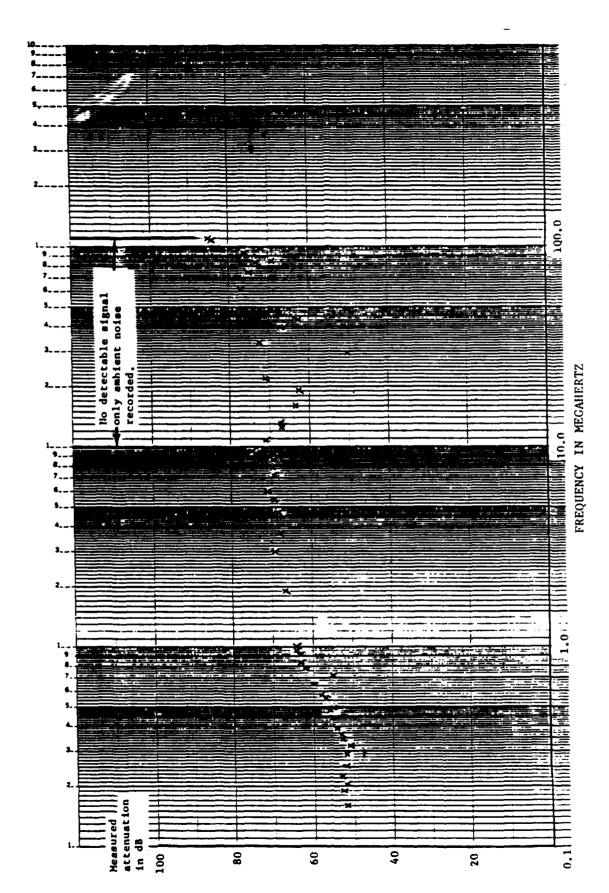
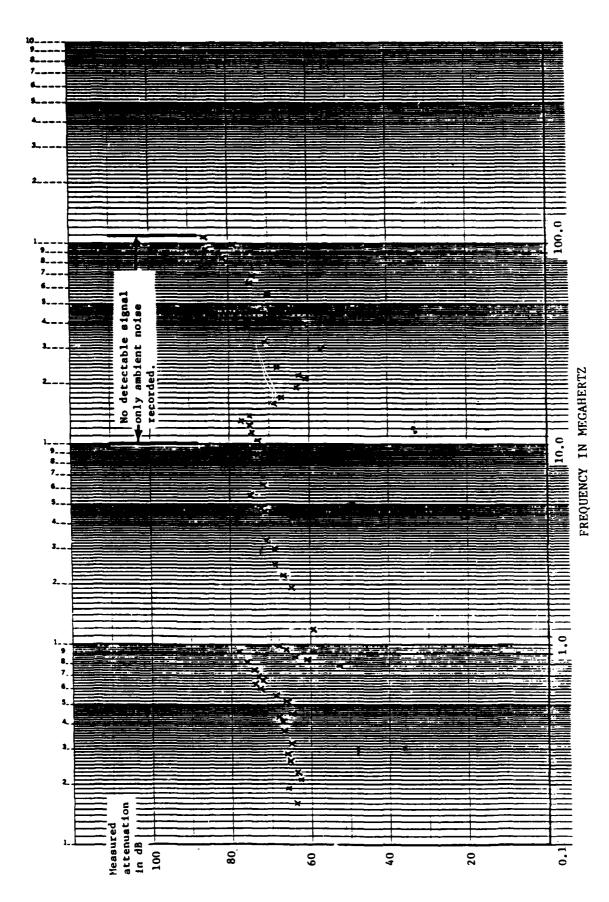
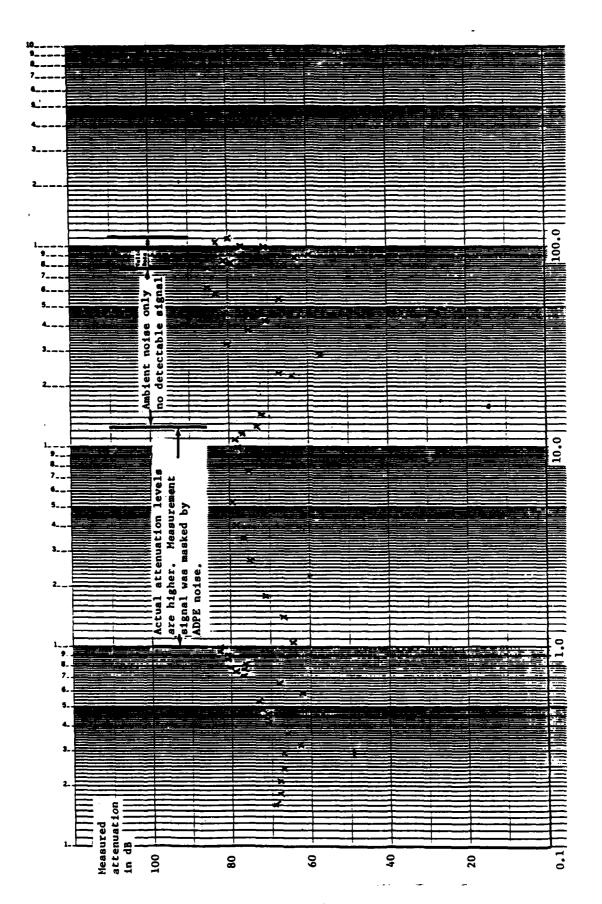
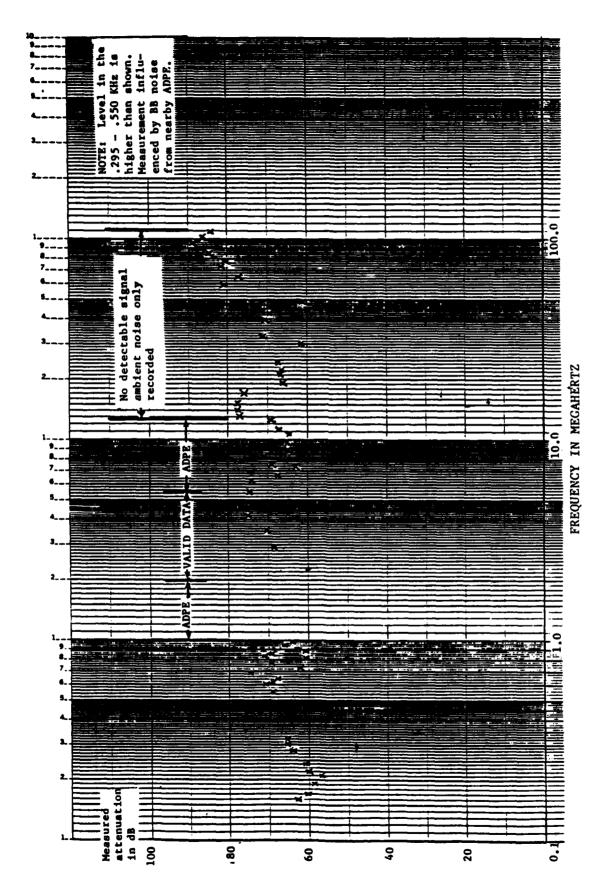
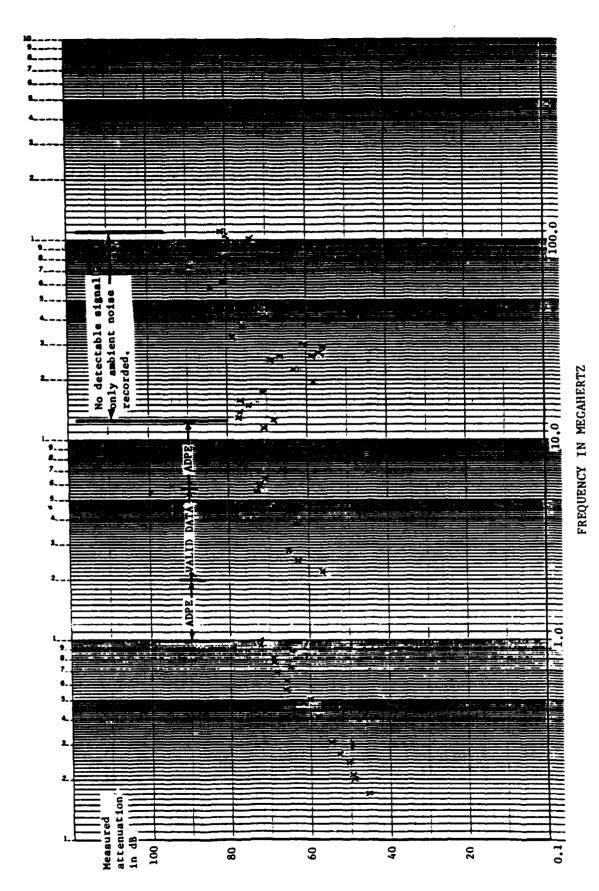
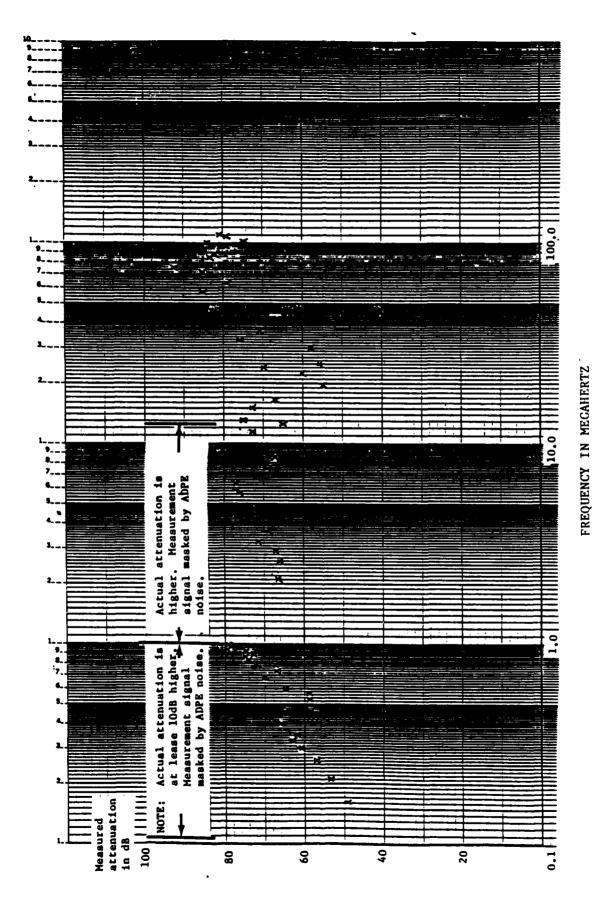
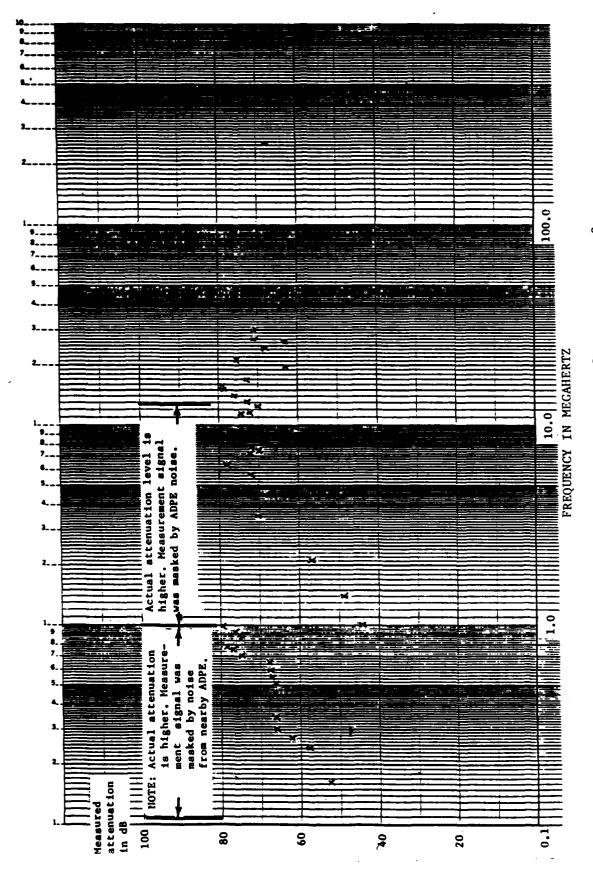
Figure 3. Measured attenuation vs frequency - seam 1.

Figure 4. Measured attenuation vs frequency - seam 2.

Figure 5. Measured attenuation vs frequency - seam 3.

Figure 6. Measured attenuation vs frequency - seam 4.

Figure 7. Measured attenuation vs frequency - seam 5.

Figure 8. Measured attenuation vs frequency - seam 6.

Figure 9. Measured attenuation vs frequency - seam 7.

Figure 10. Measured attenuation vs frequency - seam 8.

Figure 11. Measured attenuation vs frequency - seam 9.

The measured attenuation of the enclosure for seams 1 through 9 is shown in Figures 3 through 11. The measured attenuation for seams 14 and 15 is shown in Figures 12 and 13. The measured attenuation at the door gaskets is shown in Figures 14 through 16.

In most cases, the measured attenuation values range from 60 to 80 dB over the frequency range measured. Measured attenuation values near the door indicated no substantial degradation of the finger stock or significant leakage around the door.

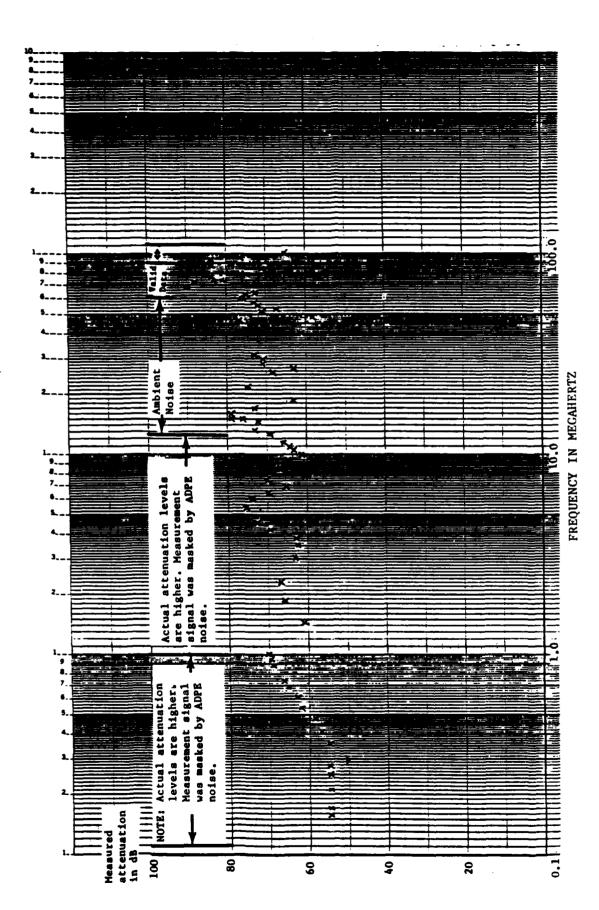
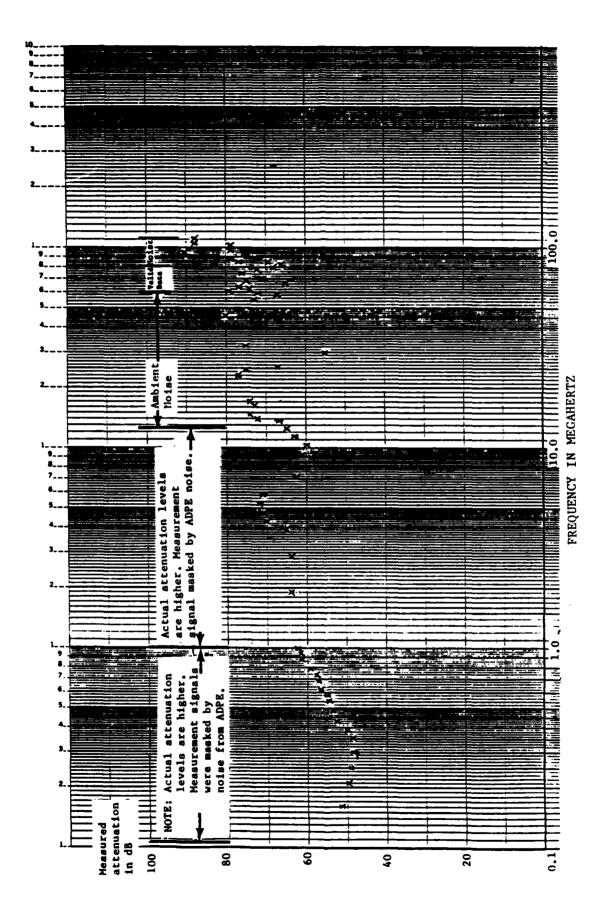
Figure 12. Measured attenuation vs frequency - seam 14.

Figure 13. Measured attenuation vs frequency - seam 15.

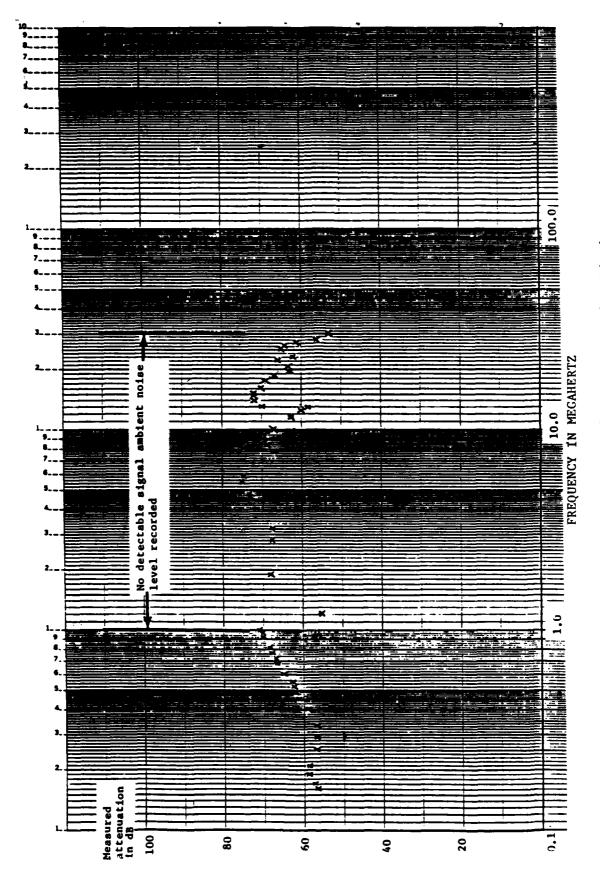
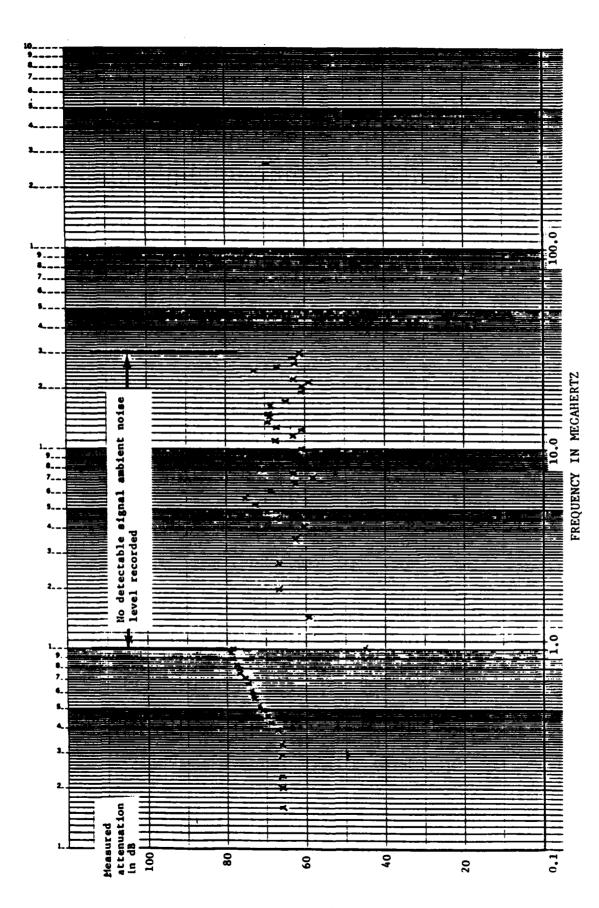
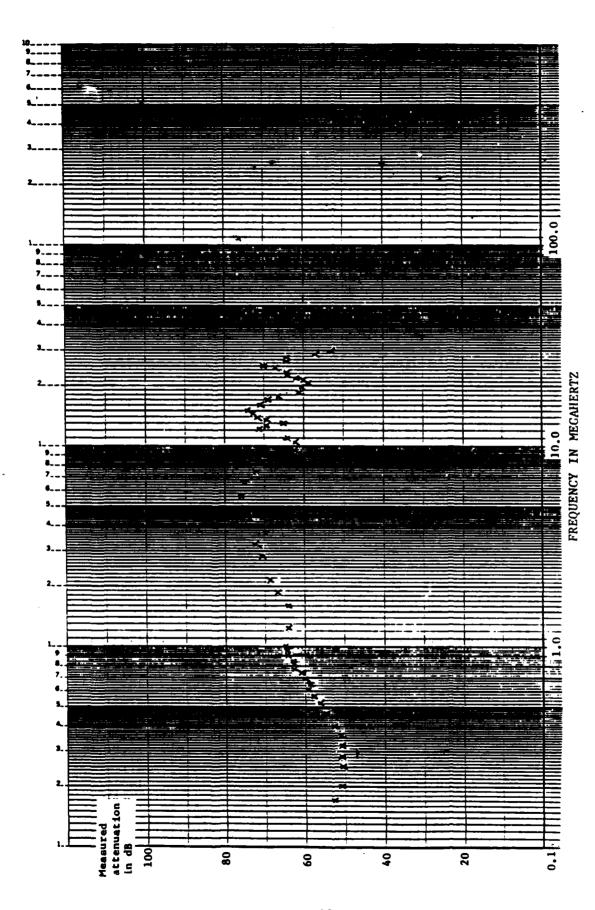
- right side door seam. Measured attenuation vs frequency Figure 14.

Measured attenuation vs frequency - left side door seam. Figure 15.

Figure 16. Measured attenuation vs frequency - upper door seam.

- A. The electromagnetic attenuation of the shielded enclosure is close to specification in the region tested (200 MHz and below).
- B. Although some physical damage is evident to the enclosure door finger stock, no significant leakage was found.
- C. A cursory measurement of the attenuation of the power line filters indicates they are performing properly.
- D. Present indications are that the noise problems experienced during previous testing were caused by conduction of rf energy into the enclosure on the shields and cables entering through the access panel at the west end of the enclosure.

- A. Repair the broken finger stock on the enclosure door. It does not appear to be a problem yet, but may become one in the future if left uncorrected.

- B. Clean the interface between the finger stock and door facing with a good brass cleaner at regular intervals. Contact the enclosure manufacturer for recommendations on products to use for this purpose.
